CIVIL AERONAUTICS BOARD

AIRCRAFT ACCIDENT REPORT

NORTHWEST AIRLINES, INC.
BOEING 720B, N724US
NEAR MIAMI, FLORIDA
FEBRUARY 12, 1963

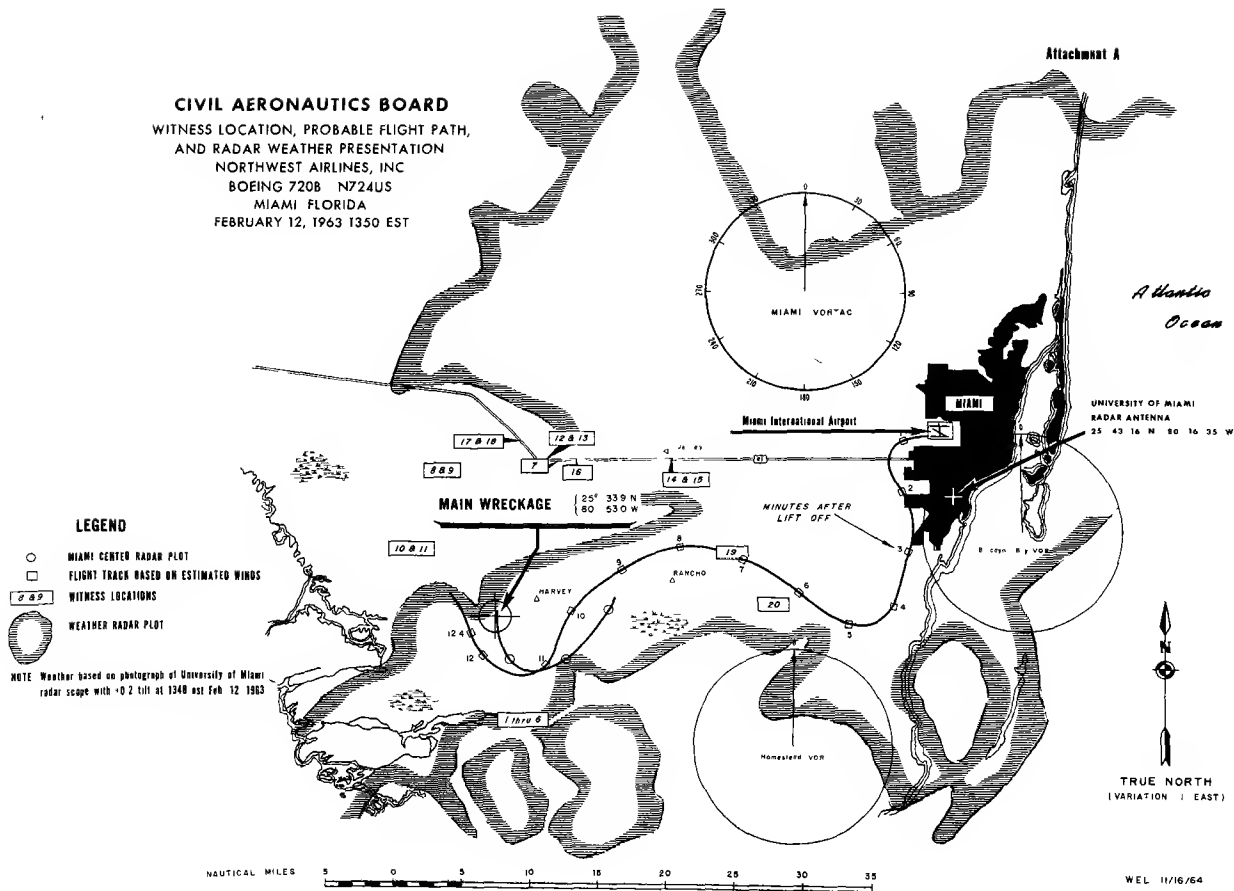
CIVIL AERONAUTICS BOARD
 WITNESS LOCATION, PROBABLE FLIGHT PATH,
 AND RADAR WEATHER PRESENTATION
 NORTHWEST AIRLINES, INC
 BOEING 720B N724US
 MIAMI FLORIDA
 FEBRUARY 12, 1963 1350 EST

The weather in the Miami area at the time of the accident was characterized by a pre-frontal squall line approximately 250 miles in length, oriented on a northeast-southwest line immediately northwest of Miami (See Attachment A). The U. S. Weather Bureau (USWB) radar observation at Miami at 1344 indicated a broken area of thunderstorms associated with this line, with cells two to twenty miles in diameter, and tops of detectable moisture at 30,000 feet. The line was moving southeast at eight knots, and moderate rain showers were occurring at the station. The 0600 and 1800 Miami radiosonde ascents showed the freezing level to have been at 11,100 and 12,400 feet m.s.l., respectively.

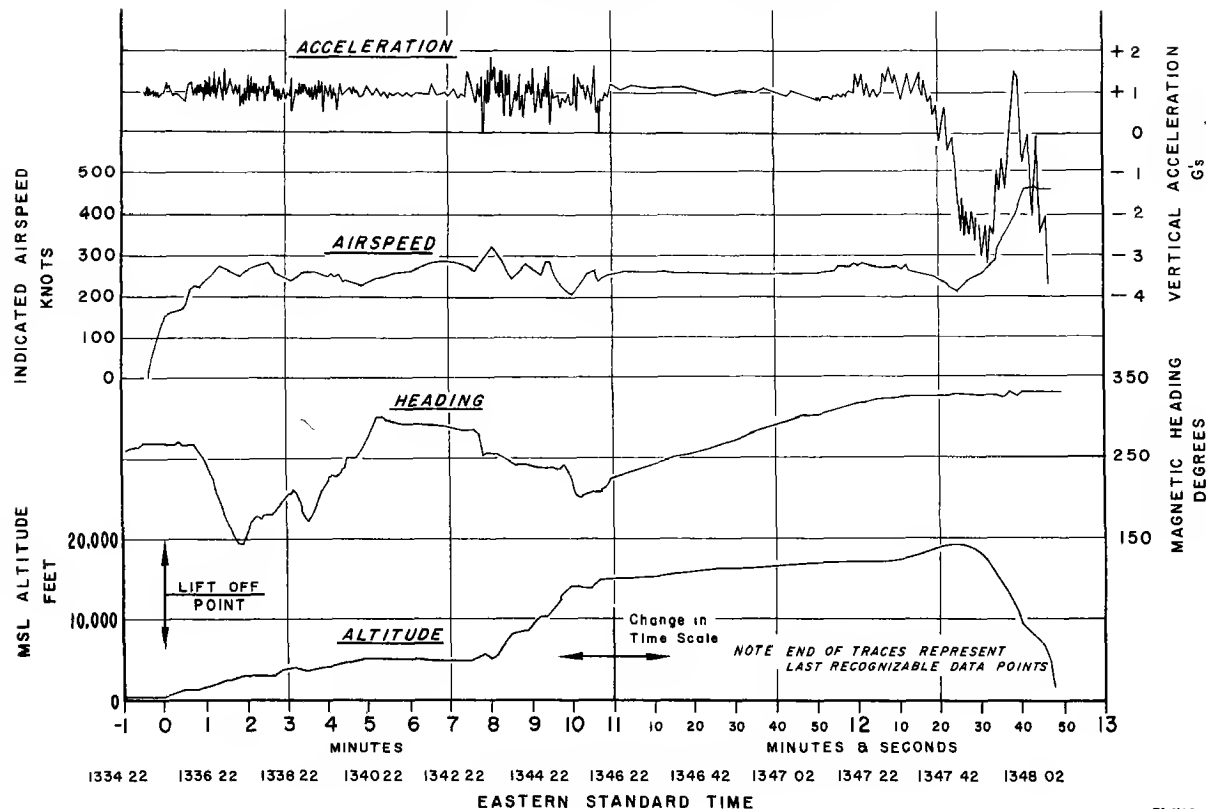
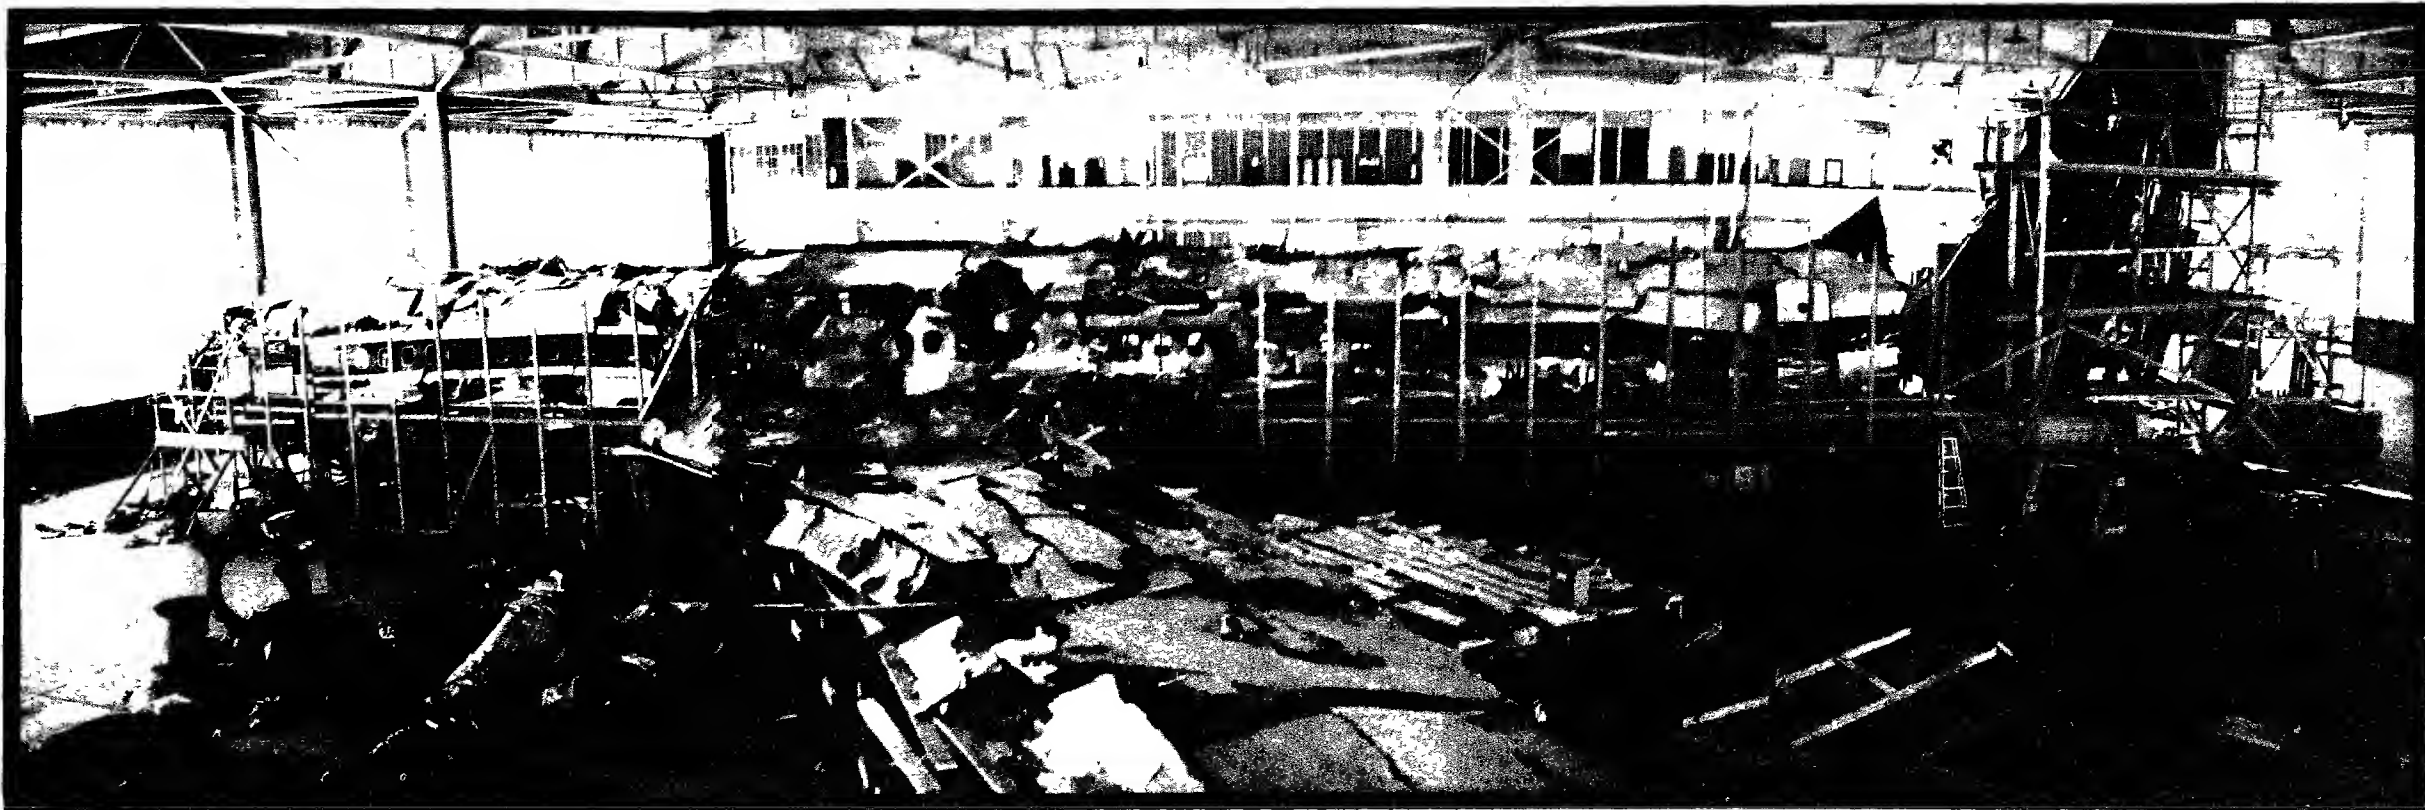
FLIGHT RECORDER DATA
 NWA BOEING 720-B N724US, MIAMI, FLA., FEBRUARY 12, 1963
 FAIRCHILD FLIGHT RECORDER, SERIAL NUMBER 1071

The aircraft was equipped with a Fairchild flight recorder which scribes oscillographic traces of in-flight pressure altitude, indicated airspeed, magnetic heading, and vertical acceleration as a function of time. The read-out of the flight recorder tape from Flight 705 (See Attachment B) indicates that following lift-off at 1335:22, a series of turns to headings of south, southwest, west, and northwest were accomplished while climbing to 5,000 feet in light turbulence. At 1342:46, as a climb was begun, heavier turbulence was encountered for approximately three minutes, until a left turn to 200 degrees was accomplished just prior to the cessation of the large acceleration excursion. The indicated airspeed fluctuated from 320 knots to 210 knots, and the altitude increased from 5,000 feet to 15,000 feet. The aircraft continued climbing from 15,000 feet to 17,250 feet in a right turn which continued through 320 degrees while the climb ceased and altitude remained constant for about 12 seconds. At 1347:25 the altitude began increasing again and the rate of climb gradually increased to approximately 9,000 feet per minute at 1347:38. Following this the rate of climb decreased through zero at 1347:47 when the altitude peaked momentarily at 19,285 feet. During this climb the airspeed decreased from 270 to 215 knots and as the peak altitude was approached the vertical accelerations changed rapidly from $+1G$ to about $-2G$. In the next seven seconds the negative acceleration continued to increase at a slower rate, with rapid fluctuations, to a mean value of about $-2.8G$, while altitude was lost at an increasing rate. As the descent continued with rapidly increasing airspeed, the acceleration trace went from the high negative peak to $+1.5G$, where it reversed again. In the last

nine seconds of the readout the altitude trace continued to decrease, the air-speed trace increased until the stylus hit the mechanical stop, the acceleration trace increased in a negative direction, and the heading remained fairly constant at 330 degrees. The final maneuver from the onset of the climb at 1347 25 lasted approximately 45 seconds.
